Ohio Geology Newsletter

WHEN THE HILLS COME TUMBLING DOWN— LANDSLIDES IN OHIO

by Michael C. Hansen

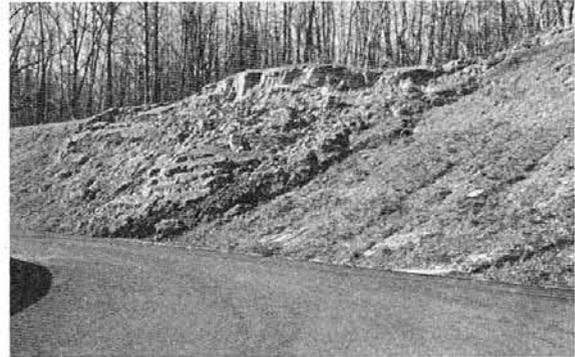
Rotational slump in Conemaugh (Pennsylvanian) red beds, Athens County.

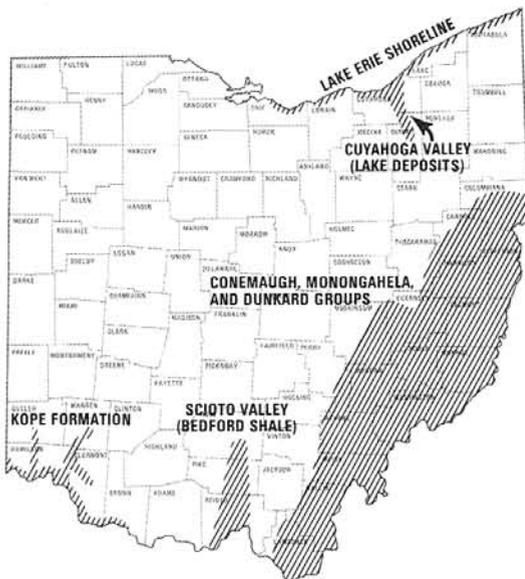
Areas of most severe slope failure in Ohio.

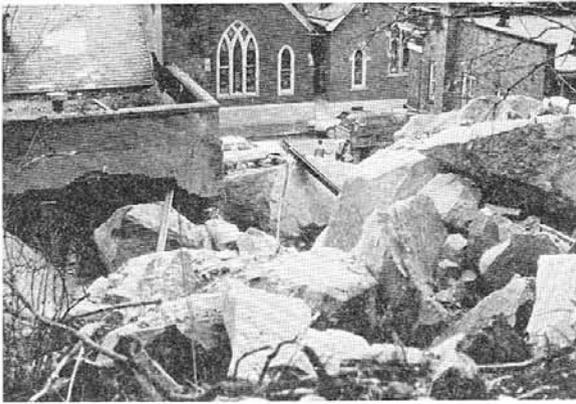
Post office partially destroyed by rockfall of massive sandstone in 1971 at Pomeroy, Meigs County.

At 2:00 a.m. on December 2, 1971, approximately 830 cubic yards of sandstone, principally in the form of large blocks, fell from a cliff in Pomeroy, Meigs County. Several of these blocks bounded into the mail-sorting room and parking lot of the Pomeroy post office, destroying a corner of the building and filling the parking lot with rock. Had this rockfall taken place during regular business hours at the post office, injury and loss of life would certainly have occurred.

The sandstone cliff at this location is cut by joints that run parallel to the cliff face. Beneath the sandstone is a weak

shale that has been eroded, thus providing little basal support for the overlying sandstone. Apparently, surface water penetrated into the joints, expanding them during the freeze-thaw cycle and triggering the failure.

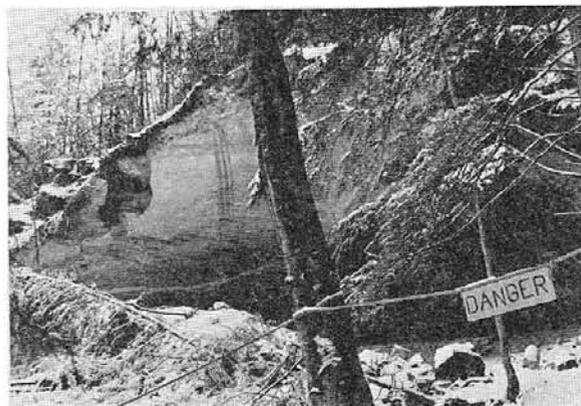
Rockfall of Black Hand Sandstone at Lower Falls, Old Mans Cave, Hocking Hills State Park, Hocking County, January 1978.

Another rockfall that perhaps narrowly averted disaster occurred during the early morning hours of January 7, 1978, at the Lower Falls at Old Mans Cave in Hocking Hills State Park, Hocking County. A large block of Black Hand sandstone (uppermost member of the Cuyahoga Formation, Mississippian), with a volume of approximately 500 cubic yards, was detached along a cross joint and fell into the plunge pool of Lower Falls. At this point in the valley the 40-foot-thick lower portion of the Black Hand sandstone forms a rock-shelter cave, approximately 200 feet long and 50 feet deep. The Fairfield Shale Member of the Cuyahoga Formation is a weak, incompetent unit beneath the Black Hand Sandstone Member; erosion of the shale removed basal support.

This rockfall occurred after a heavy rain the preceding day that was followed by subfreezing weather. It is probable that increase in weight of the sandstone by saturation from rainfall and freezing of moisture in the cross joint were responsible for failure of the overhanging sandstone at Lower Falls. Another rockfall had occurred at this site in 1940. Fortunately, no one was injured in the 1978 rockfall. Had it occurred during the day, especially in summer, the results would have not been so fortunate. This particular portion of the gorge normally receives a large number of visitors.

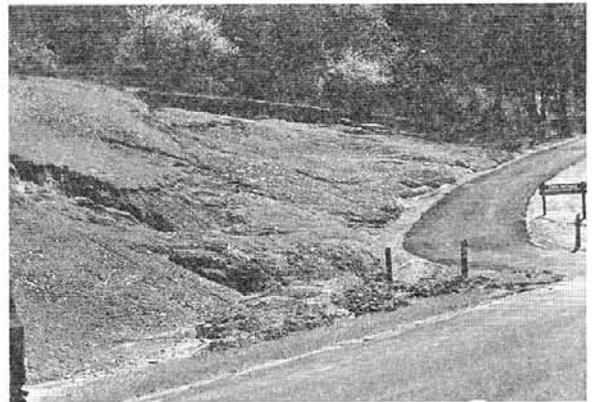
Small slump in colluvium of the Kope Formation, Hamilton County. Photo by E. Mac Swinford.

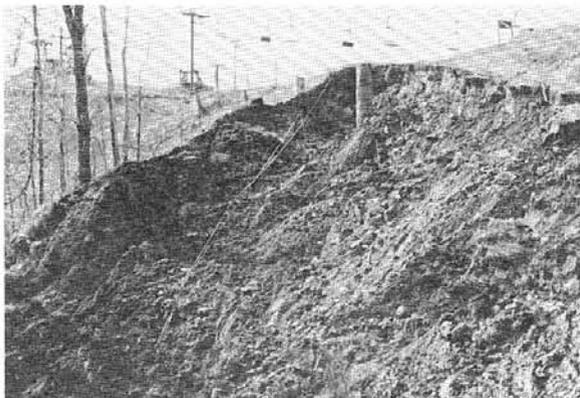
Landslide in Cuyahoga Valley lake sediments near Boston Mills, Summit County. Photo by Sherry L. Weisgarber.

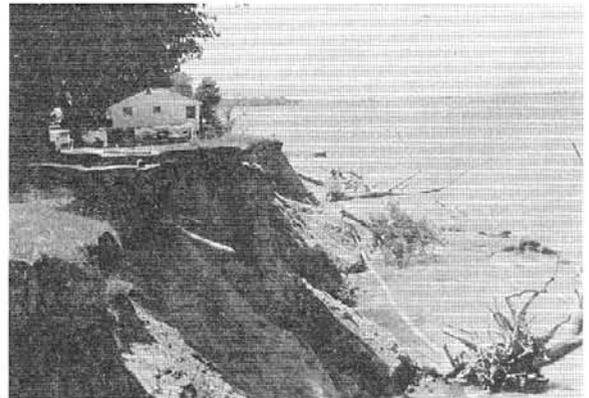
Bluff recession on the Lake Erie shoreline threatening a home near Huron, Erie County. Laminated clays such as these are very susceptible to undercutting by waves.

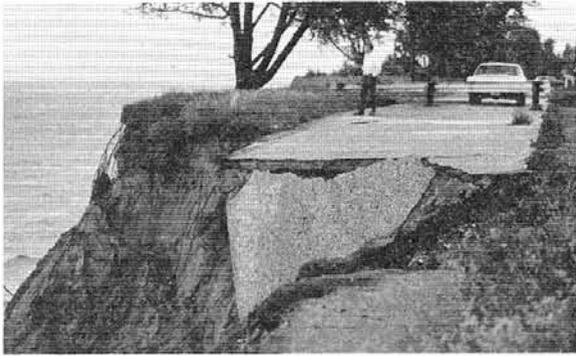
Road destroyed by landslide in bluff of glacial till along Lake Erie shoreline, Lake County.
