LANDSLIDES IN OHIO

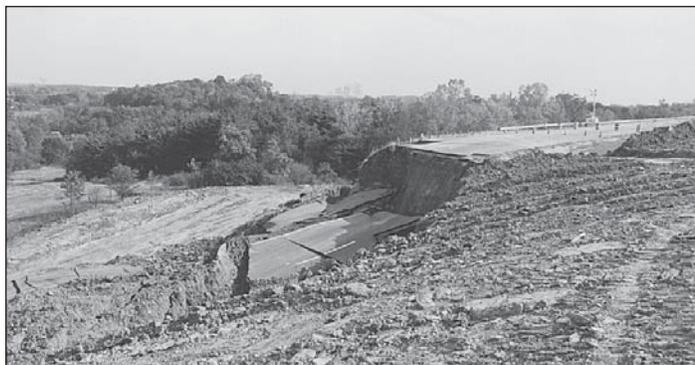
Landslide in westbound lanes of I-70 near New Concord, Muskingum County, 1986.

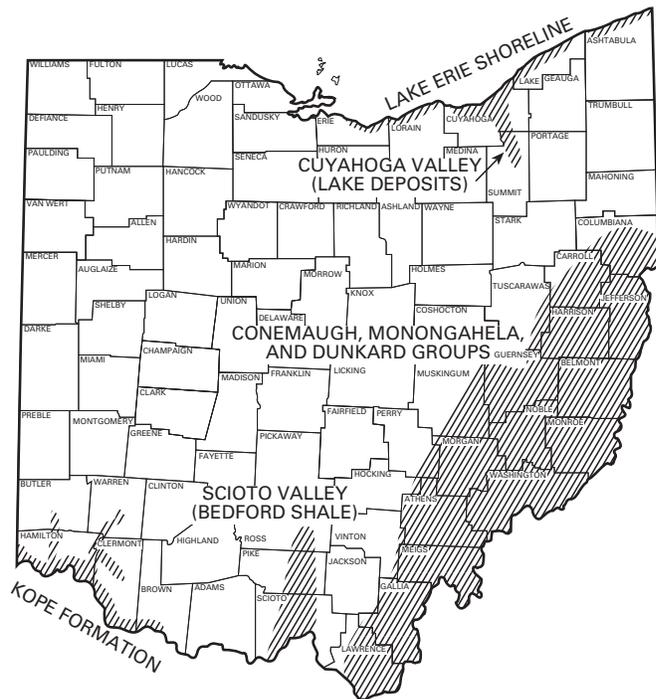
Areas of Ohio subject to severe slope failure.

Portions of eastern and southern Ohio are characterized by steep slopes and local relief of several hundred feet. In addition, bedrock of Mississippian, Pennsylvanian, and Permian ages, thick colluvium (deposits of broken and weathered bedrock fragments), and thick lake silts and outwash formed in association with Pleistocene glaciers make this area particularly prone to slope failures. The most slide-prone rocks in eastern Ohio are red mudstones ("red beds") of Pennsylvanian and Permian age. These rocks tend to lose strength when they become wet, forming rotational slumps or earthflows. About 85 percent of slope failures in this region are in red beds of the Pennsylvanian-age Conemaugh and Monongahela Groups.

In the lower part of the Scioto River valley, thick colluvium developed on shales of Mississippian age, particularly the Bedford Shale, is prone to failure. Also prone to failure are lake clays and silts that accumulated in some valleys in this area when Pleistocene glaciers dammed the north-flowing preglacial Teays River system.

Portions of Cincinnati (Hamilton County) and surrounding counties where rocks of Ordovician age are exposed are prone to numerous and costly landslides in the form of rotational slumps and earthflows. The majority of bedrock slope failures are in the shale-dominated Kope Formation and to a lesser degree in the Miami Shale. Landslides tend to occur in the thick colluvium developed on these units when excessive hydrostatic pressure builds up in this zone.

The valley of the Cuyahoga River between Cleveland and Akron, in Cuyahoga and Summit Counties, is well known for rotational slumps in clays and silts deposited in lakes formed when glaciers of the Pleistocene Ice Age blocked various segments of the valley. The modern Cuyahoga River has cut through these deposits, leaving steep bluffs of unstable sediments along the valley walls. Many

The eastern half of the Ohio portion of the Lake Erie shoreline, from Cleveland to Ashtabula, is characterized by unconsolidated glacial sediments such as till and lake clays and silts that are highly susceptible to wave erosion at the base of the bluff. Such erosion is accentuated during periods of high lake levels accompanied by large storms. The continual removal of slumped sediment by waves prevents natural achievement of stability of the slope. Many lakeshore homes, roads, and other structures have been destroyed in these areas, where bluff recession is as rapid as 7 feet per year.
