BUILDING STONES OF THE OHIO CAPITOLS

Educational Leaflet No. 19
2011

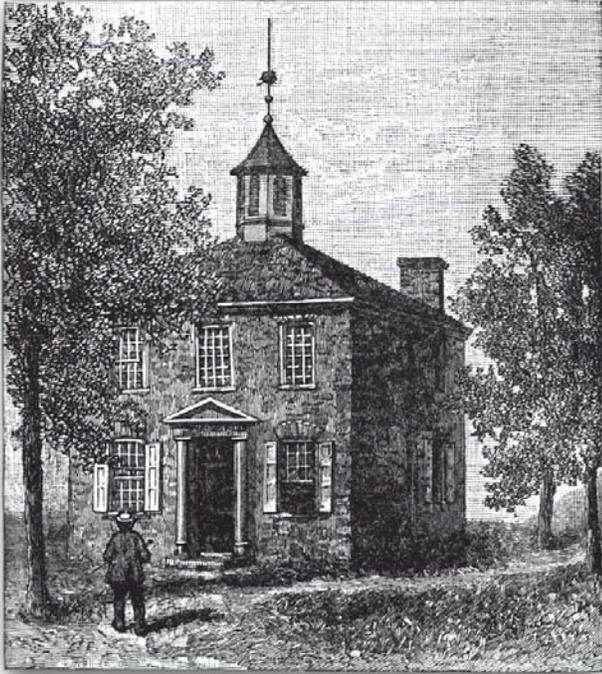
Ohio's first statehouse in Chillicothe, Ross County, circa 1803. Courtesy FCIT.

Ohio's first statehouse was constructed of Devonian-age Berea Sandstone, quarried by Major Rutledge to the immediate southwest of Chillicothe at Cemetery Hill. Fortescue Cuming, a traveler passing through Chillicothe in 1807, remarks in his diary that "...freestone... got in the neighborhood, is of whitish brown colour, and excellent for building." The Berea Sandstone in this area is usually 25 to 35 feet thick, with individual beds generally 6 to 12 inches thick. The Berea is a fine-grained, light-gray sandstone that weathers to light brown. The Berea Sandstone was used to construct many homes

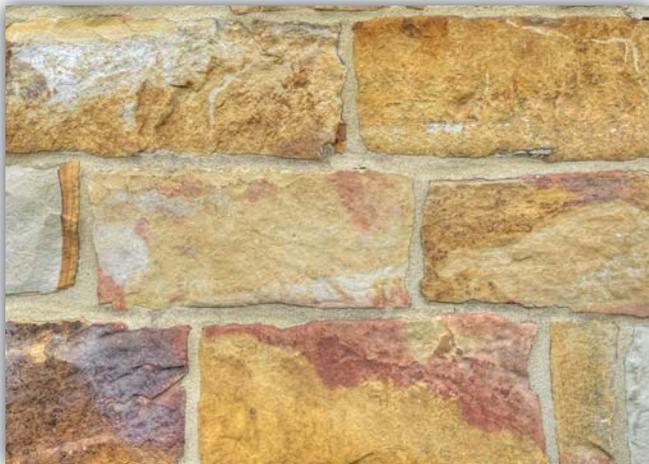
Berea Sandstone of the Adena Mansion in Chillicothe, Ross County. The Berea Sandstone was used to construct Ohio's first statehouse, also in Chillicothe.

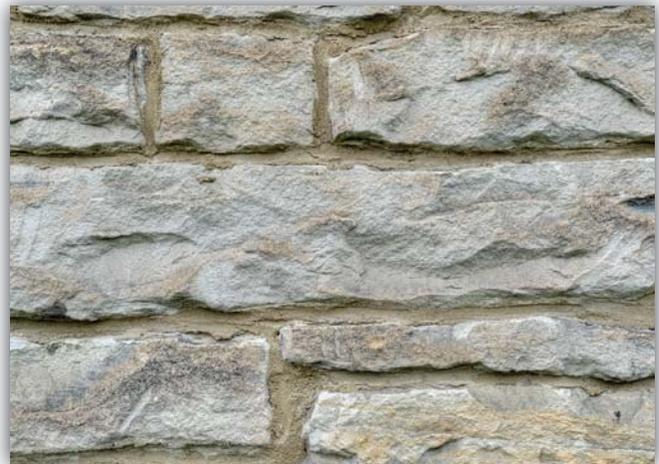
Weathered "Homewood" sandstone of the Stone Academy in West Zanesville, Muskingum County. The "Homewood" is very similar to the "Clarion" sandstone originally used for the second Ohio Statehouse in Zanesville.

The Stone Academy at Putnam (West Zanesville) was constructed in 1809 originally to be used as the new statehouse; but after intense political maneuvering, a competing brick building across the Muskingum River in Zanesville was chosen by the state legislature instead. The Stone Academy is currently owned by the Pioneer and Historical Society of Muskingum County and represents the sole remaining public structure in Ohio from the early 1800s. The building stone for the Stone Academy, a Pennsylvania-age Pottsville Group sandstone informally known as the "Homewood," is light brown, fine to medium grained, thick bedded to massive, micaceous (contains mica), and is approximately 27 feet thick at the former quarry.

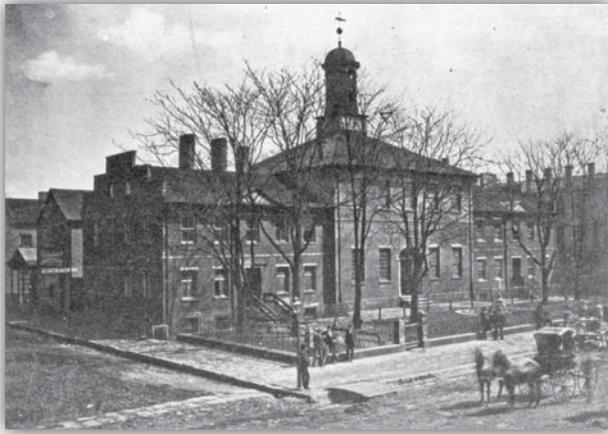
Ohio's second statehouse in Zanesville, Muskingum County, circa 1850–1870. Ohio Historical Society photo.

The statehouse in Zanesville was completed in 1809. The Zanesville statehouse was an imposing two-story brick structure with a cut-stone foundation and trim that resembled Independence Hall in Philadelphia. James Hampson is generally considered the builder of the Zanesville statehouse. Jacob Houk supervised the stone and brickwork. And a man identified only as "Mr. Greene" was the mason responsible for cutting the sandstone into caps, window sills, and the 1809 date stone. The second Ohio statehouse, affectionately called "Old 1809" by the locals, was torn down in the 1870s to make way for the new county courthouse. The skillful masonry of the original building is preserved in the oval-cut, one-piece "1809" date stone transferred from the original statehouse and now found above the main entrance to the current Muskingum County courthouse.

The brick used to construct the statehouse in Zanesville was handmade by John Lee at his brickyard, near Underwood Street. The brick was produced from the excellent Pennsylvanian-age clays and shales found near Zanesville. The Pennsylvanian-age sandstone used for the foundation and trim most likely came from the Townsend quarries north of Zanesville, which supplied a large portion of the building stone used in Zanesville during the early 1800s. The sandstone quarried at Townsend is from the lower portion of the Allegheny Group and informally named the “Clarion.” The “Clarion” is a medium- to coarse-grained, light-brown sandstone that is micaceous in part and often cross-bedded. The “Clarion” sandstone is 20 to 30 feet thick at the former Townsend quarries.

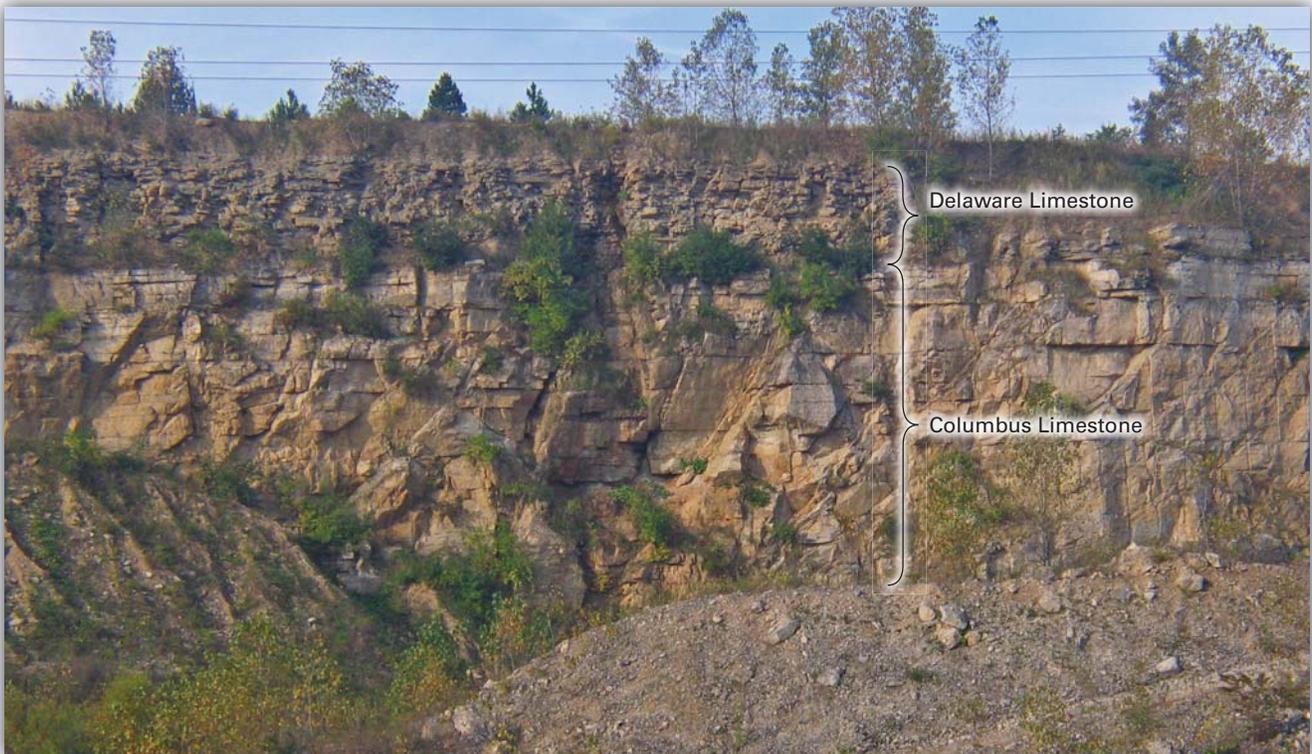
West highwall of Marble Cliff Quarry exposing Delaware Limestone (dark-colored, thin-bedded unit) overlying the Columbus Limestone (light-colored, massive-bedded unit). 2004 photo.

In 1859 William Mather, who had previously served as the first State Geologist of Ohio, reported on the drilling of a water well on the statehouse grounds. Mather named the limestone encountered the Columbus Limestone. There are two members of the Columbus Limestone, the Delhi and the Bellepointe Members. The Delhi is the upper member and is generally a light-gray to white, fossil-rich limestone approximately 60 feet thick. It was the source of building stone for the current statehouse. The Bellepointe is the lower member and is a light-brown, medium- to coarse-crystalline, dolomitic limestone that is approximately 40 feet thick in the Columbus area. The Bellepointe Member is less desirable as a building stone but is used as aggregate in central Ohio.

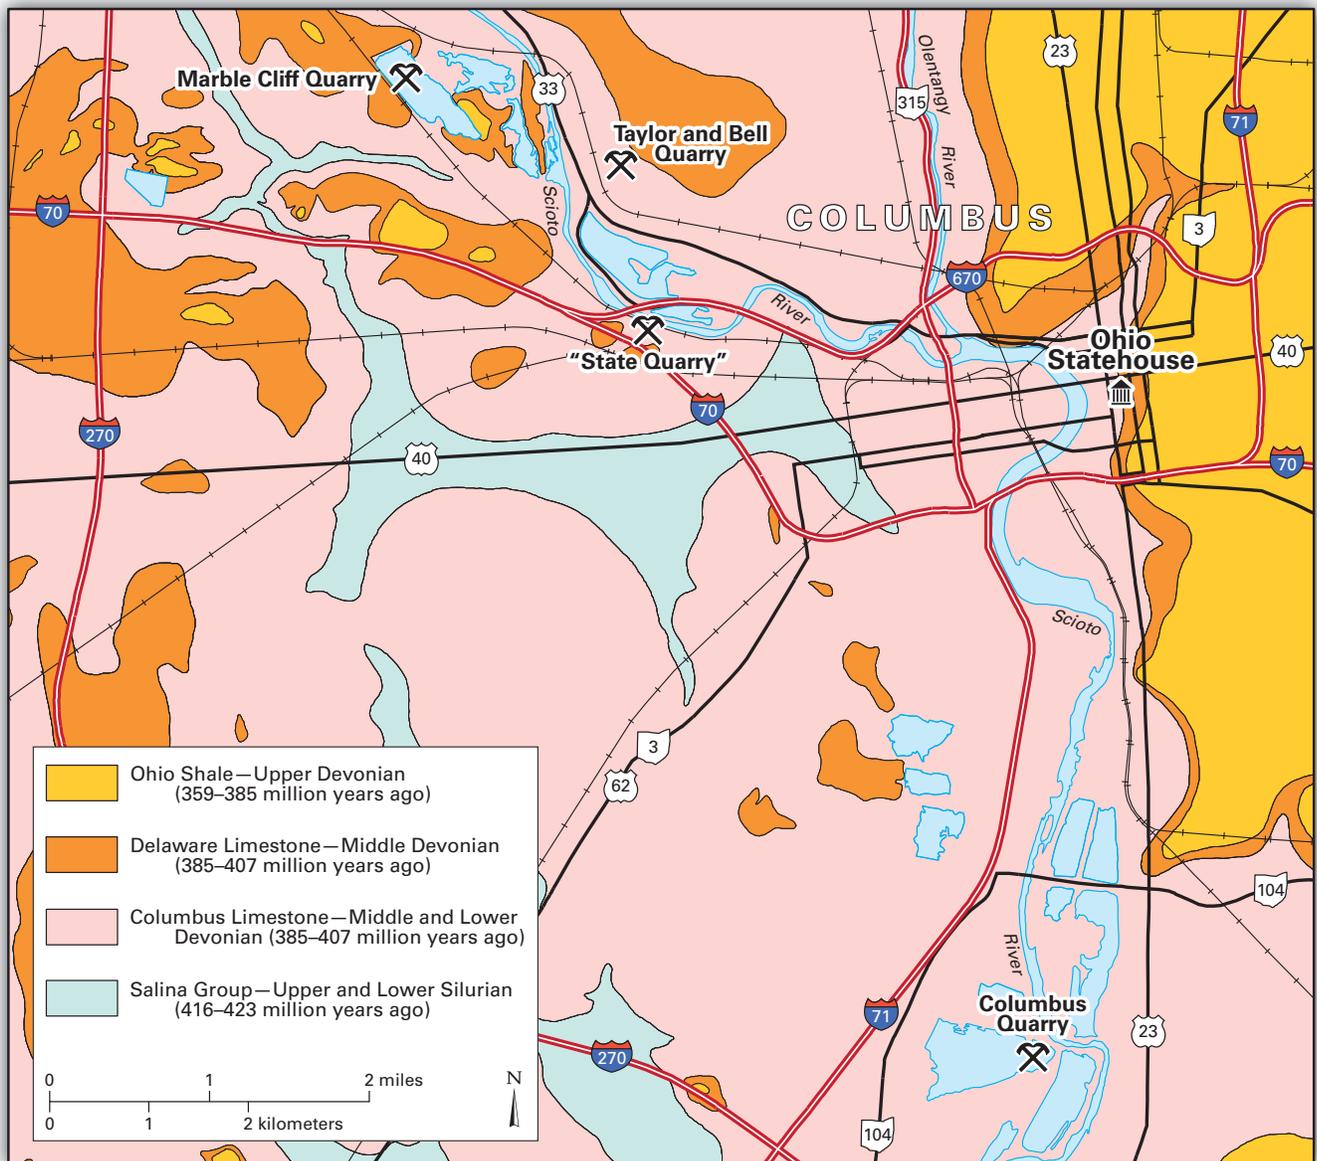
Bedrock geology map of the west-southwest Columbus area, showing approximate locations of historic and present-day quarries.

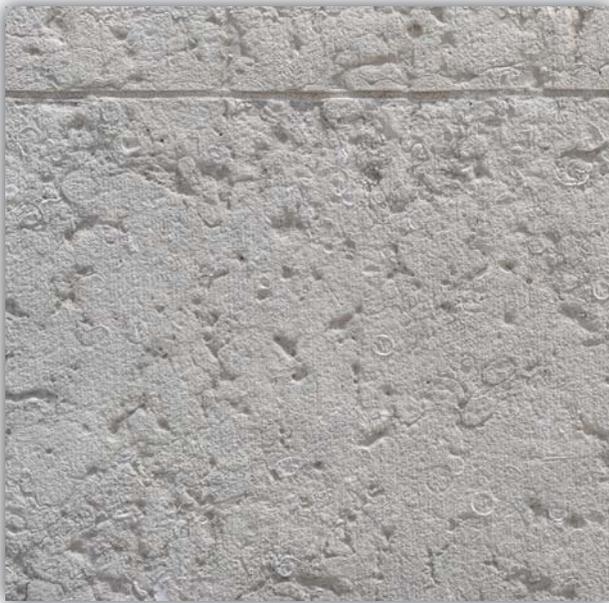
Columbus Limestone of the Ohio Statehouse in Columbus, Franklin County. Numerous fossils can be found in the exterior walls, stairs, and columns of the statehouse.

Abundant fossils, including corals, gastropods, and mollusks, are evident in the 6-foot-thick, 36-foot-high Doric columns that support the roof. The 24 columns weigh a total of nearly 2,000 tons and were produced from the lower portion of the Delhi Member in the “State Quarry.” The lower portion of the “State Quarry” also contained cranial plates of a large fish, *Macropetalichthys Sullivanti*. Coiled cephalopods, gastropods, corals, and stromatoporoids, produced from the upper portion of the Delhi Member, can be found in the steps. Tiny fossil organisms, such as graptolites and bryozoans, also are abundant; and interesting fossils, such as trilobites, can be found along the face of the building. The diverse fossils and differential weathering of the Columbus Limestone tend to enhance the aesthetic appeal of the grand building.

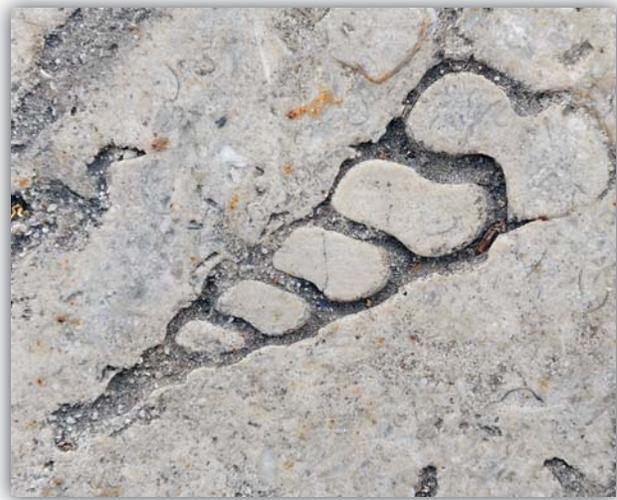
*Cross section of the steinkern (internal filling) of a high-spired gastropod (genus *Loxonema*) in the exterior stairs on the east side of the Ohio Statehouse. Shown actual size.*

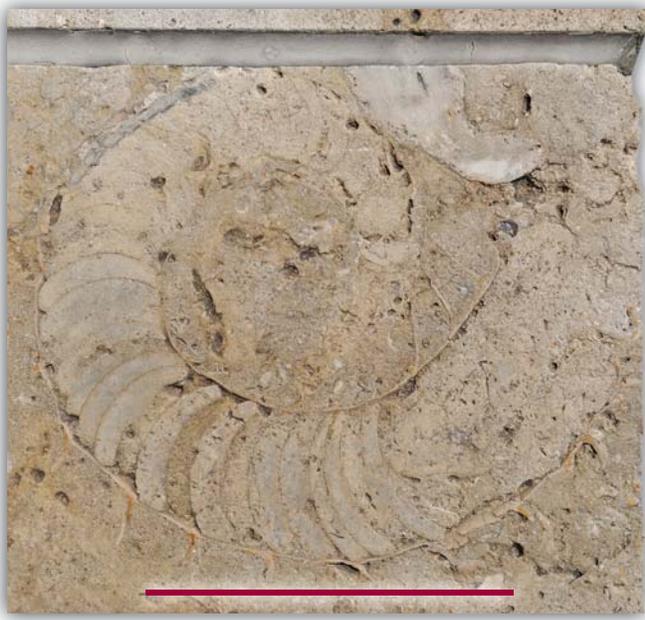
A coiled nautiloid cephalopod (genus *Goldringia*) in the exterior stairs on the east side of the Ohio Statehouse. Red bar is 5 inches in length.
